Bradford Prescott
Photographs from April 3, 2013 Inspection

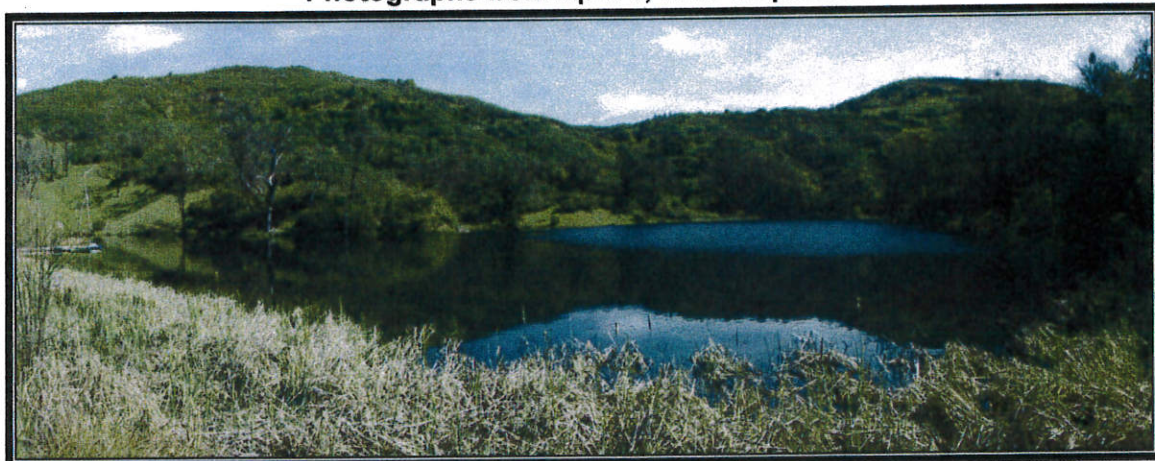
Photograph 1 – Panoramic; facing Northeast – View of reservoir from southwest corner.

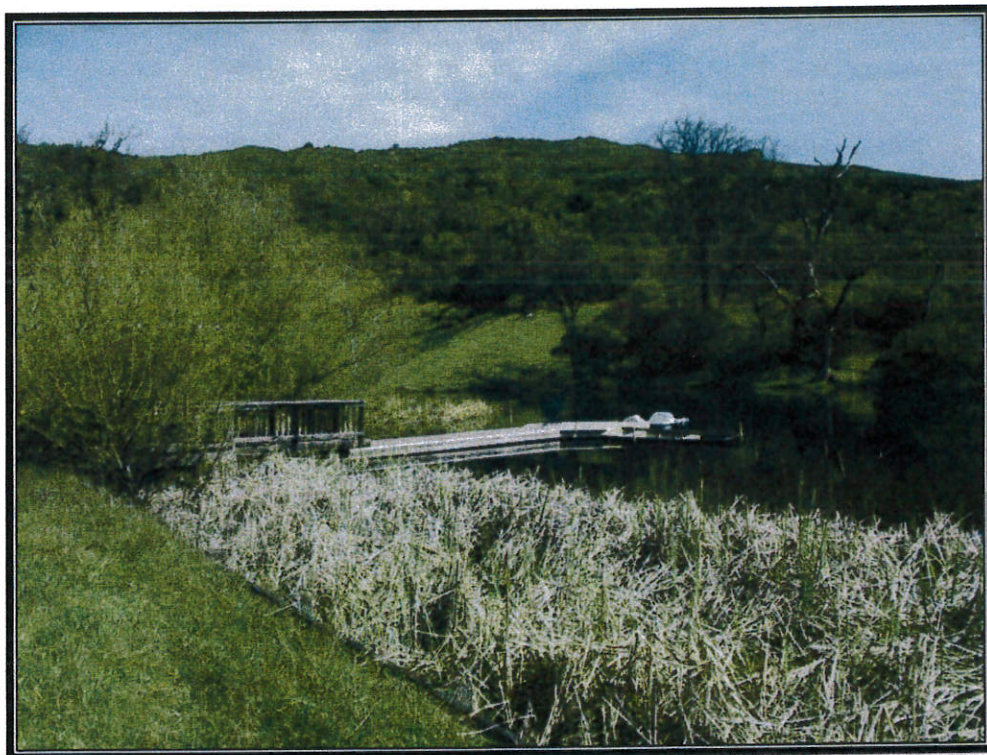
Photograph 2 – Facing North – View of northwestern corner of reservoir with floating dock and boats in the foreground.

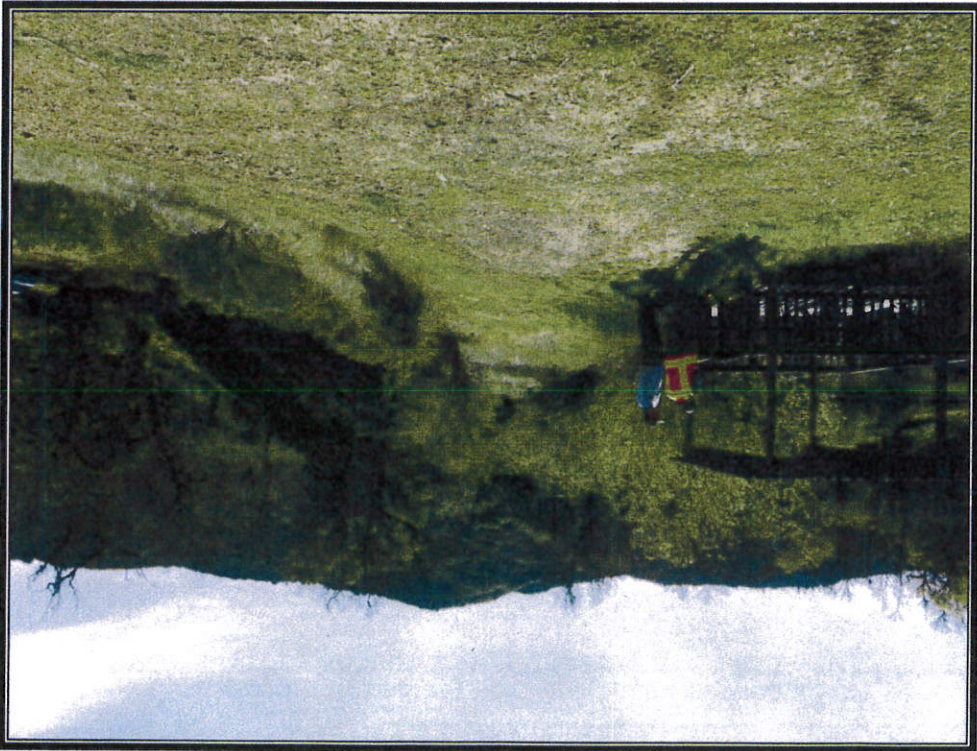
Photograph 3 – Facing South-Southeast – View of dam with shaded-dock in foreground.

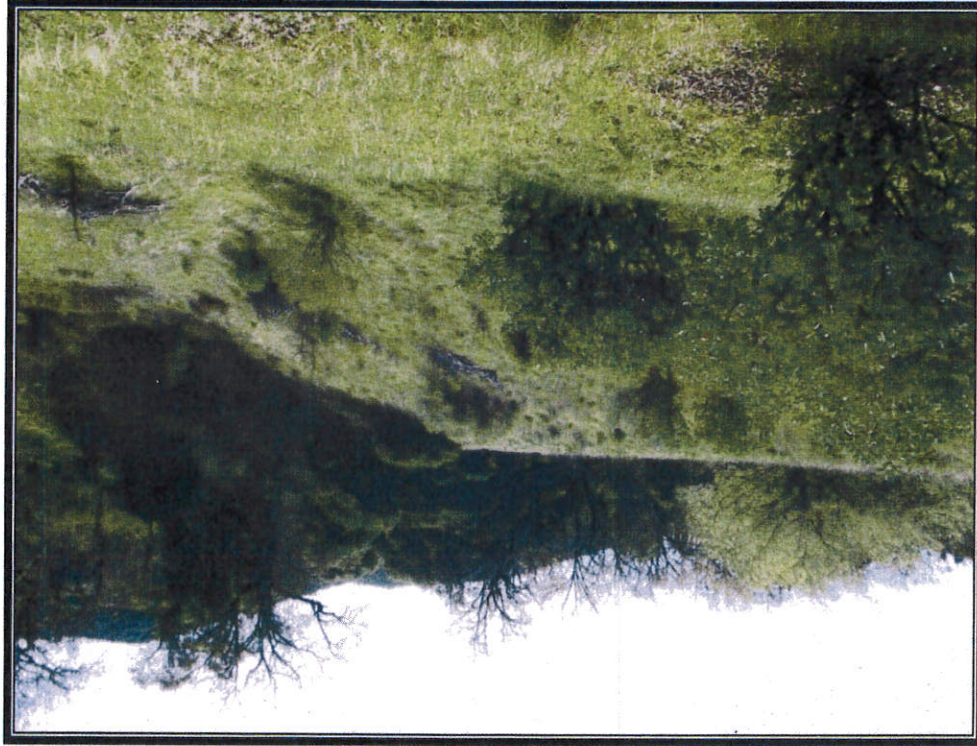
Photograph 4 – Facing Southeast – View of downstream side of dam.

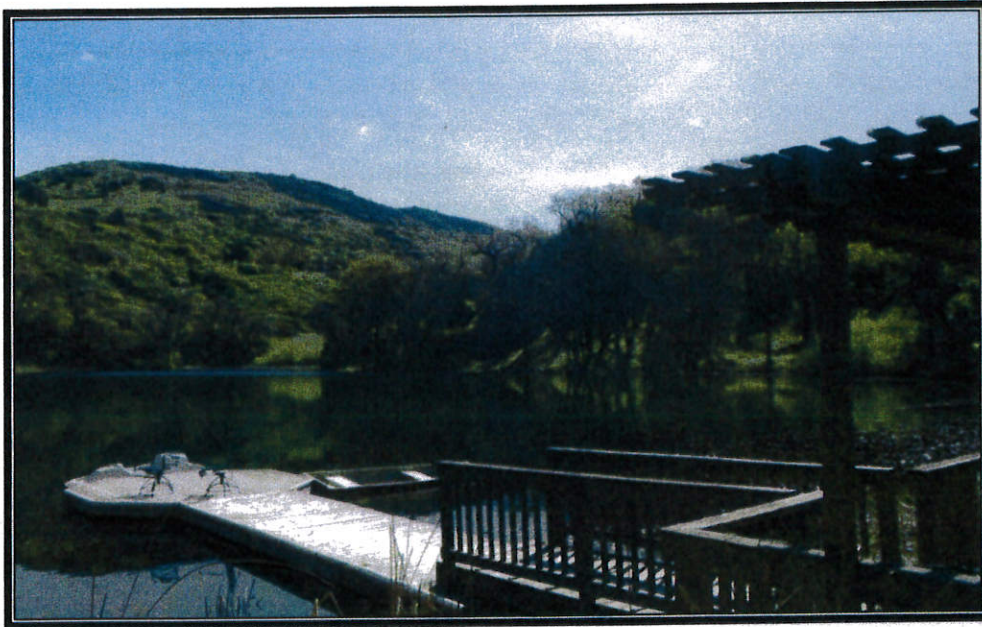
Photograph 5 – Facing East-Southeast – View of floating dock and boats with view of eastern section of reservoir and surrounding hills.

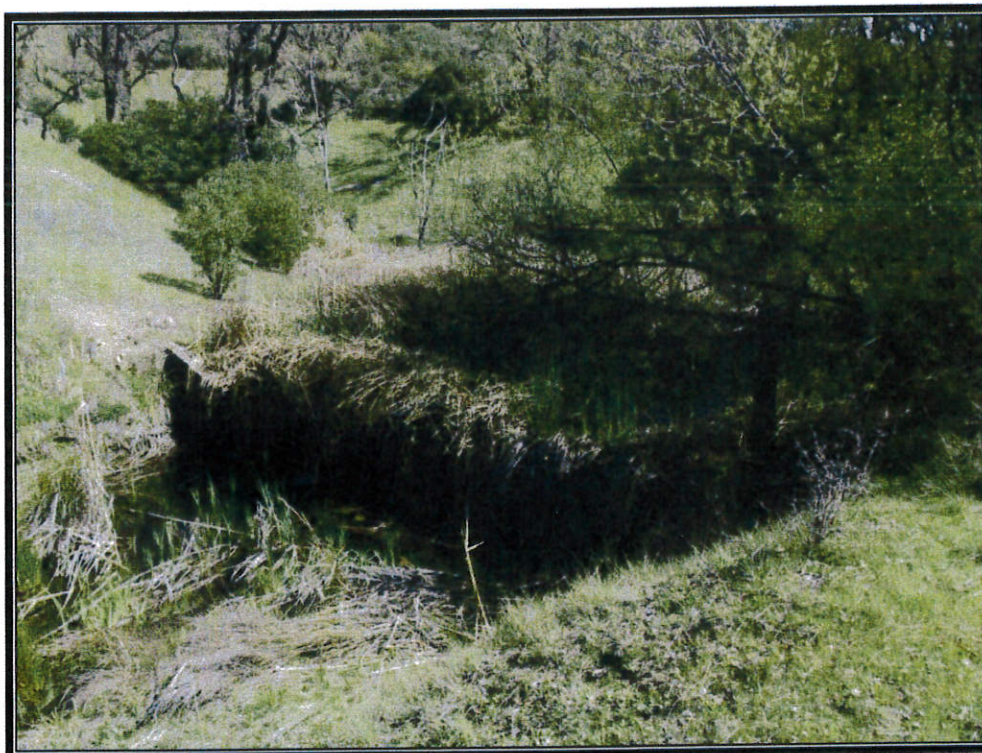
Photograph 6 – Facing North – View of spillway; spillway was spilling over at time of inspection.

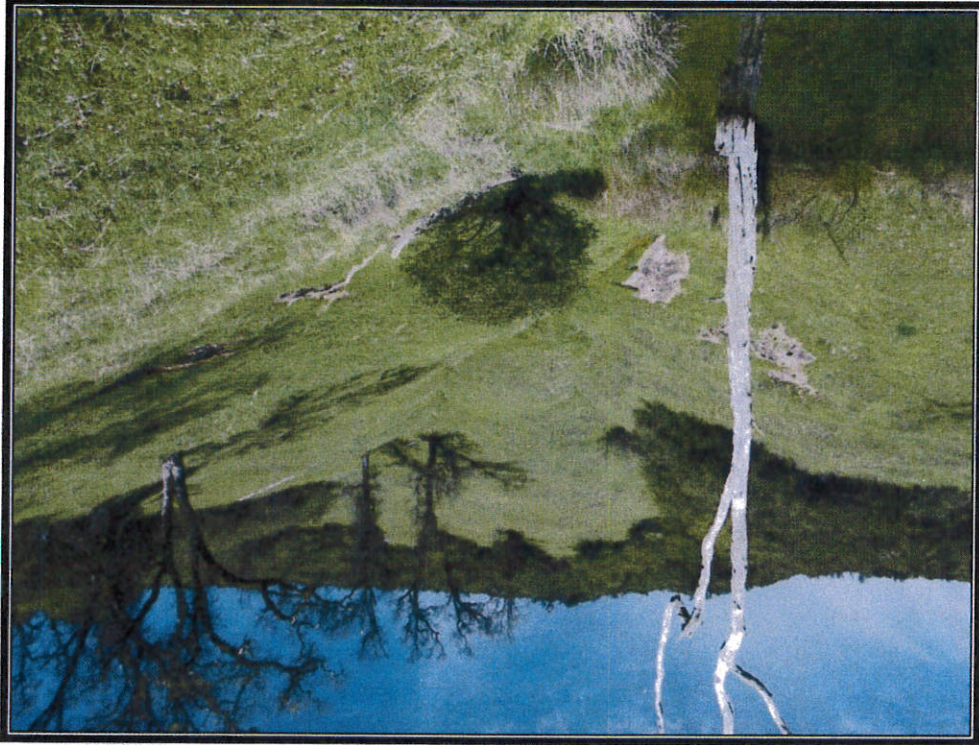
Photograph 7 – The downstream channel was flowing during the inspection.

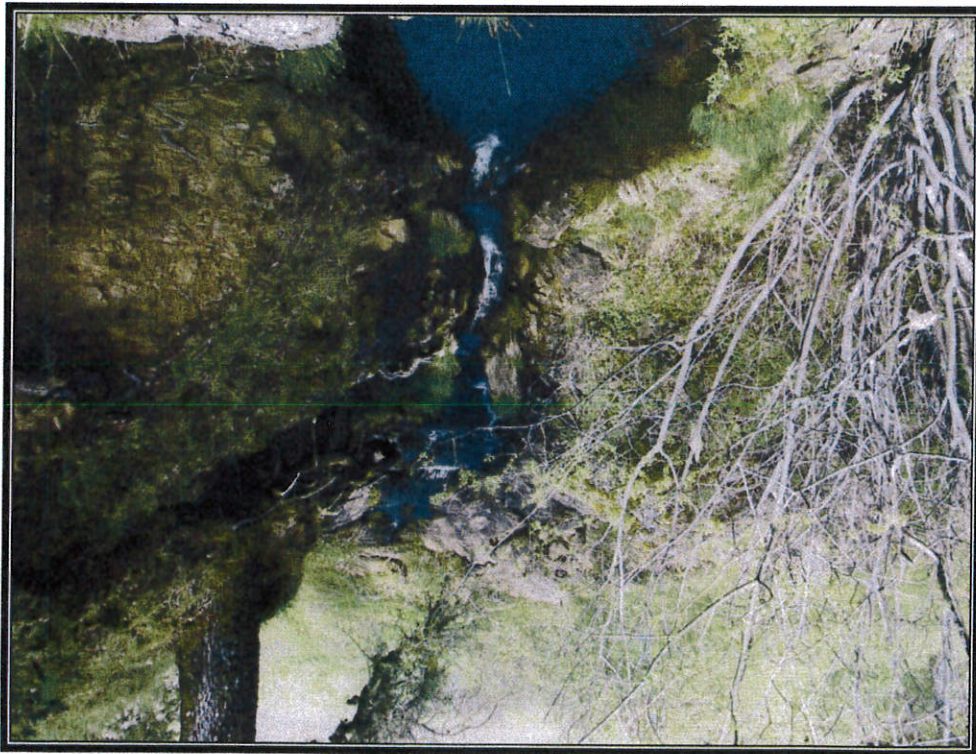
Photograph 8 – Facing North – View showing upstream channels located on the north side of the reservoir.

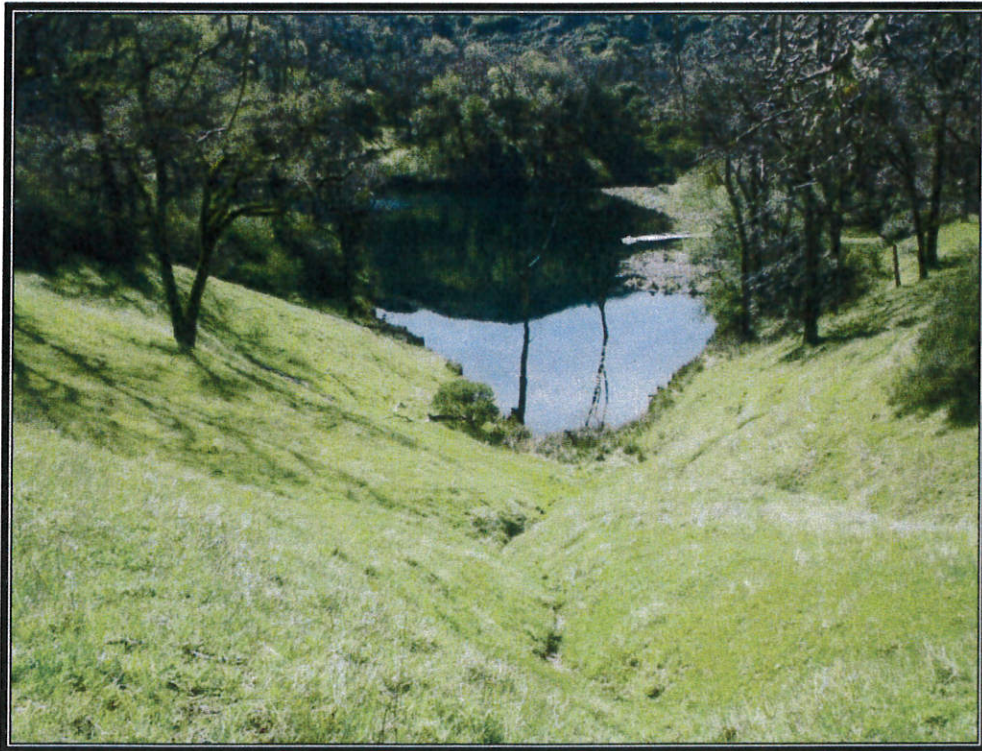
Photograph 9 – Facing South-Southeast – View from upstream channels in previous photograph looking towards the reservoir.
